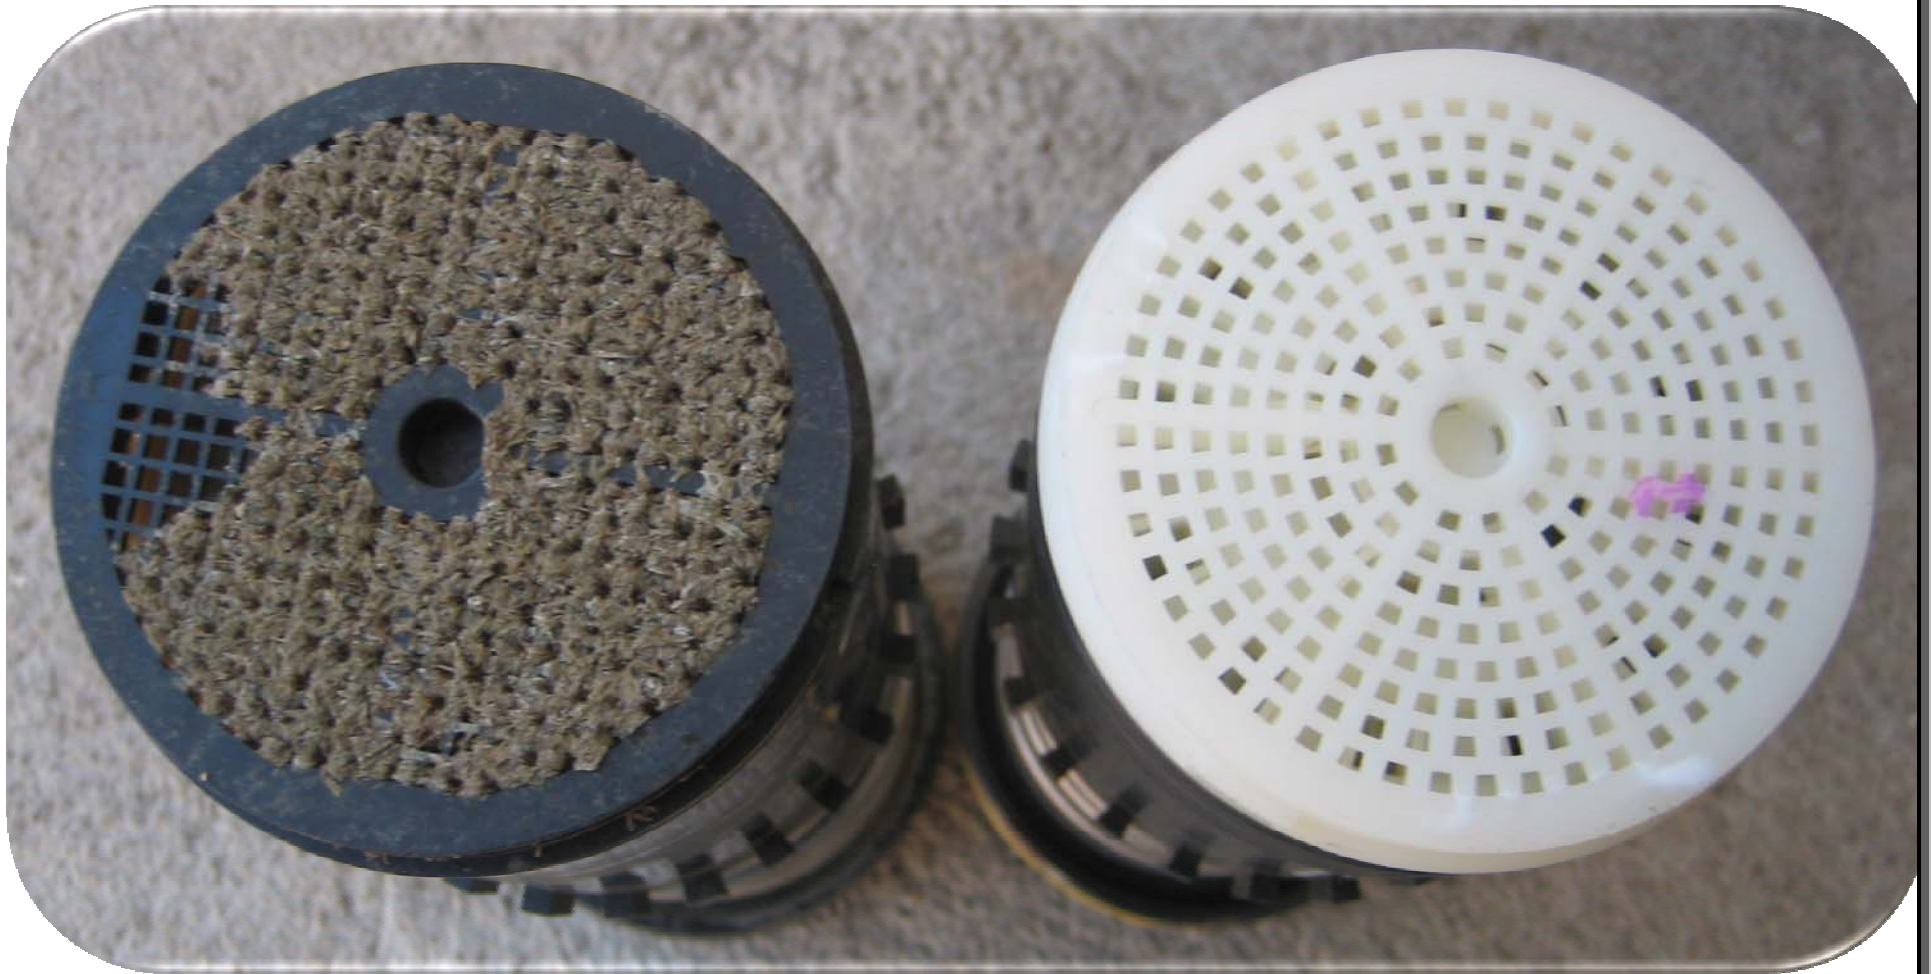
These two sprinkler heads were removed from a working golf course. The head on the left was not treated with ozone, while the head on the right was treated with ozone.

Note: both were distributing reclaimed water from the same source
